## Understanding Tuning Marks on Ceramic Patch Antennas

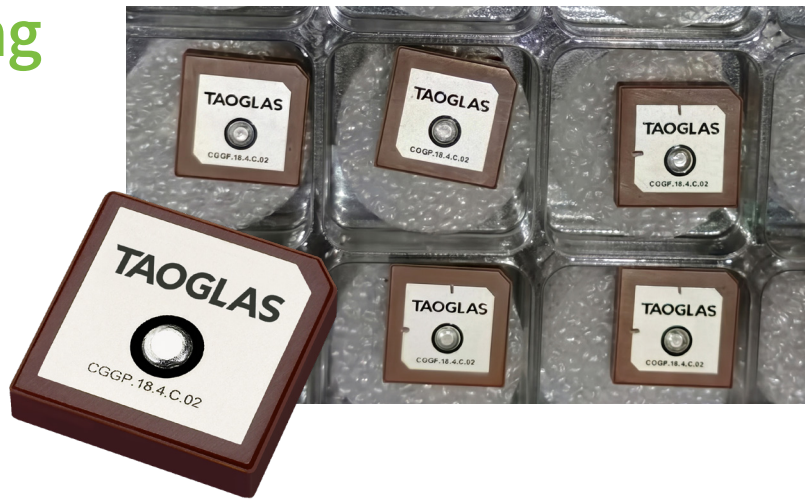
**Figure 1**

The small marks visible around the perimeter of the conductive surface are tuning notches. A controlled amount of conductive metallization is removed at an appropriate location. Changing the geometry of the conductive patch changes its electrical characteristics and allows the antenna resonance to be adjusted. Notches interrupting the perimeter of the conductive element are specifically documented as a tuning-feature approach for high-dielectric ceramic patch antennas.

Examples of tuning marks/notches on ceramic patch antennas.

No. A tuning mark produced as part of the controlled manufacturing process is not an indication that the ceramic patch antenna has been damaged. The important distinction is:

Therefore, an intentionally applied tuning feature should not be considered a cosmetic or functional defect.
