Report No.: HA70017/2018

Anam-Hexa-band cellular SM D PIFA Antenna **Product Description:**

1. Humidity Test

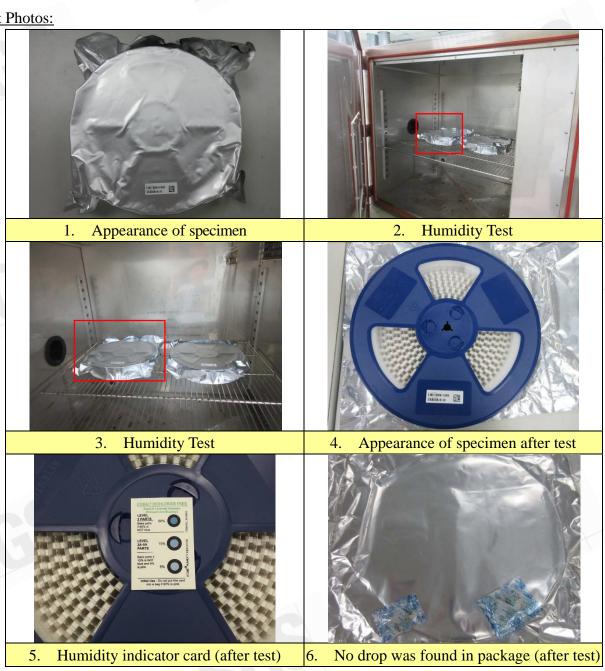
Test Photos:

Check Item Style/ Item No.	Appearance Check (Visual Check)		
	No visible damage		
PA .25A/ No.1	No drop was found inside the package		
	(See photo 4 to photo 6)
